BULB MAINTENANCE AND TROUBLESHOOTING

System maintenance is critical to long bulb life. Shown below are some bulb failure modes and their solutions.

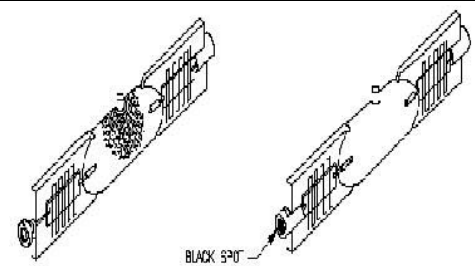
<p>Arcing indicated by a gold, brown or black spot on the ceramic ends of the bulb</p> <p>Cause: Improper seating of bulb in a lamp base causes electricity arcs from the lamp base to the bulb through a gap, which results in burning and heat.</p> <p>Solution: Lamp bases must be replaced through repair department. Shake, rattle and roll bulb to ensure proper seating of electrodes of bulb to lamp base for future bulb changes.</p>
